Kiwi Feather Props Ltd - LIMITED WARRANTY

VERSION DATED: 17.10.2017

K3 - CUSTOMER MANUAL

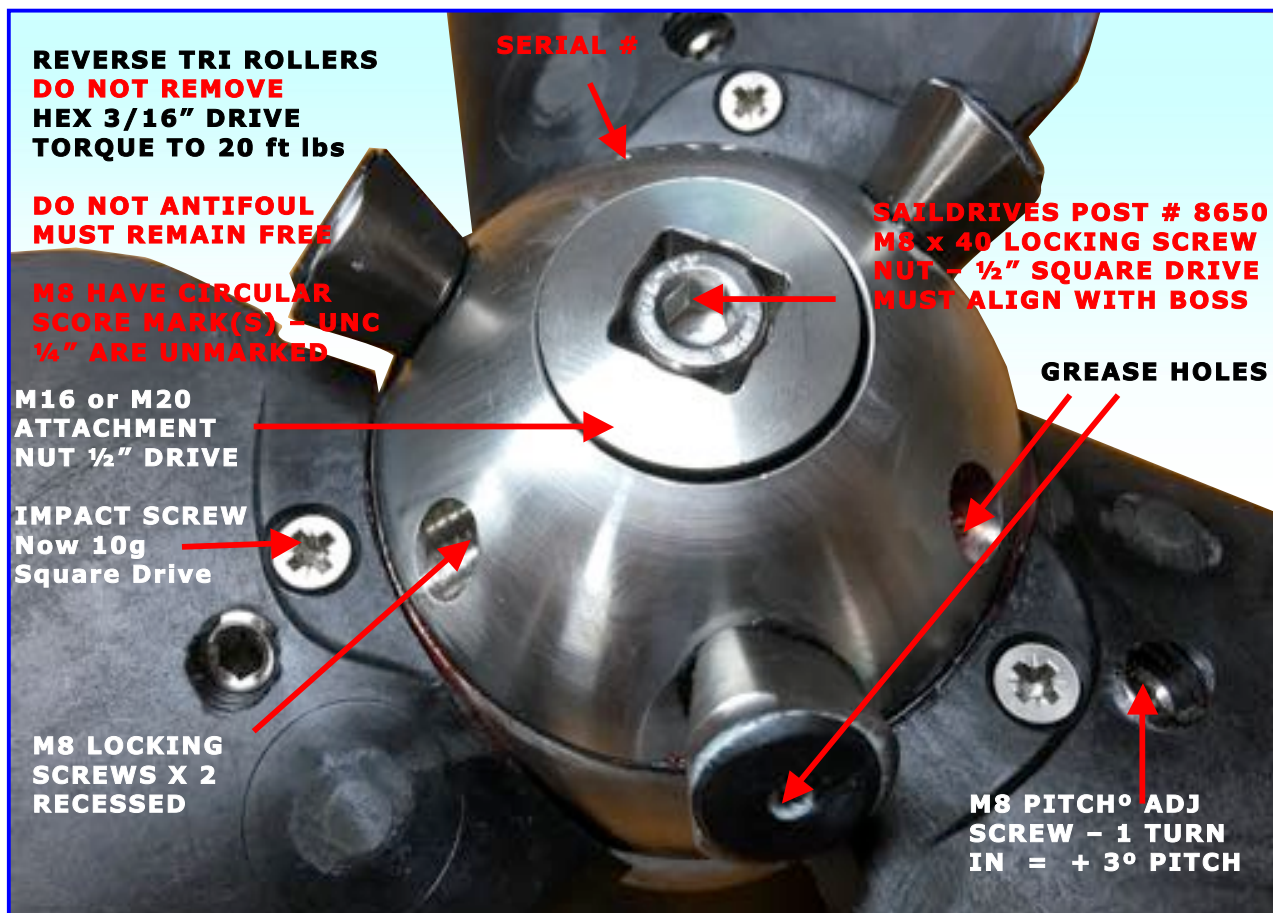
The photograph below shows a boss without the blades attached and clearly identifies the nut with it's ½" square drive recess and the two M8 locking screws that must first be backed off to allow for removal of the nut from the unit.

**NB: 1.250" NUTS
PROTRUDE ~ 13 mm
& ARE SHIPPED
WRAPPED WITH KEY**

Refer first to exploded diagram on page 9 below and to the picture of the boss on page 2

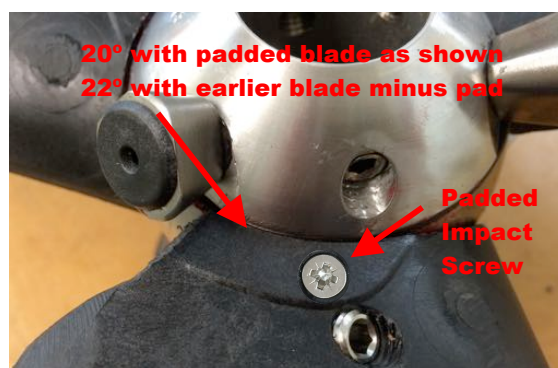
The photo shows a padded blade pushed into the forward thrust position to eliminate any slack with pitch set to 20 deg. The aft of the rear blade surface aligns with the SS aft joint line. Allow for any wear showing on the rear surface of the blade.

Add or subtract one degree of pitch using 1/3 rd of a turn = 1 degree of pitch. For example 22 degrees of pitch would be 2/3 rd of a turn in ie clockwise from the 20 Deg reference shown with padded blade. The screws are self locking into the blade.

Check the blade has been remounted on it's old pin. Now mount the retaining pin back into the reverse face of the blade from the side it came out of with a new wear face on the pin facing outwards. By tapping gently - reinsert the pin so that it is equidistant from each outer face of the blade. Refer photograph above for illustration.

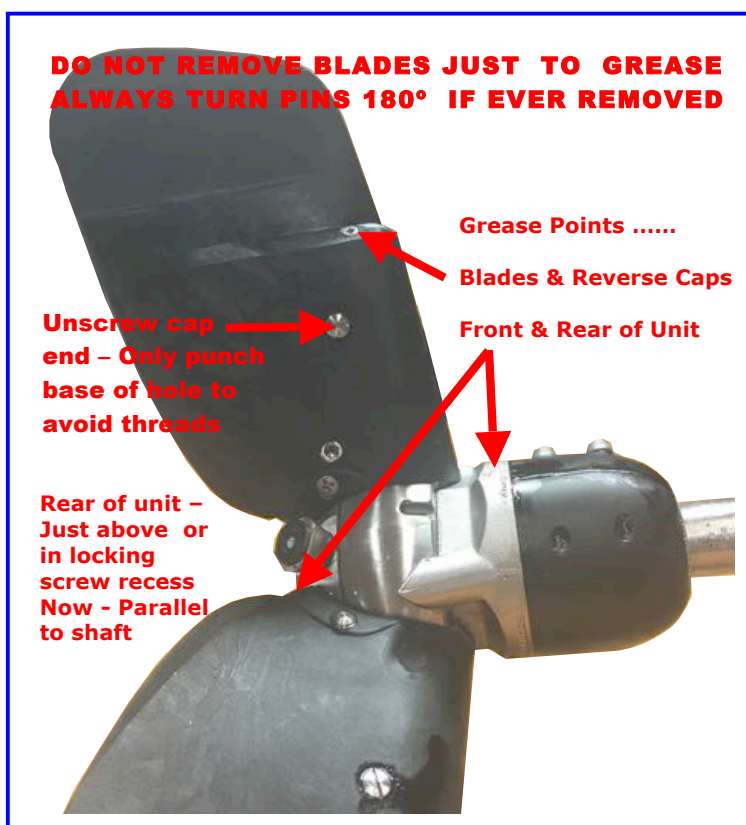
The *Kiwiprop*™ contains lubricants sufficient until your next maintenance haul out. Each blade and reverse roller cap (if present) must then be greased via a lubrication point accessed by removing the small Pozidrive stainless screw on the blade face. In addition there are two small grease holes, one very close to the GF PP nose cone in the SS casting that takes the thrust of the pitch screws and one near the outer perimeter of the sphere at the rear of the unit inside the locking screw recess. These have been chamfered to accept a standard needle nosed grease point that we provide with every unit. **DO NOT OVER GREASE AND DAMAGE SEALS – JUST FILL – DO NOT FORCE EXCESS OUT.** Each of these grease points should be filled with a high quality marine grease: Grade - NLGI No 2: CALTEX Delo ESI has performed well and is readily available.

Check the reversing rollers are free to turn and free up if necessary with CRC. Grease the caps on later model units

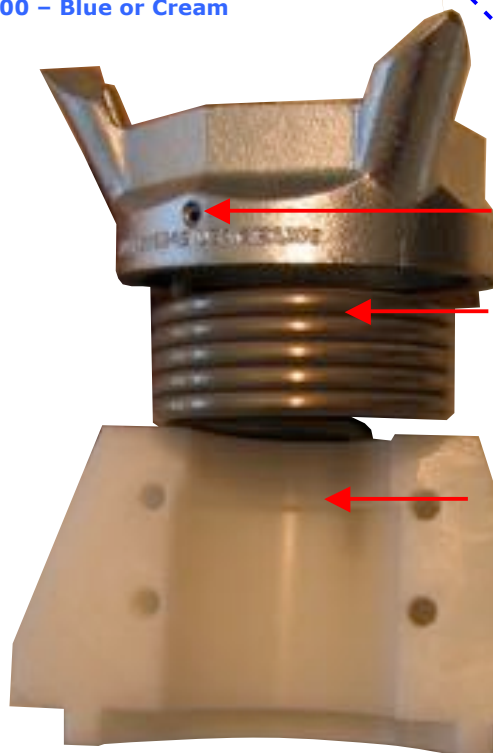
Propeller Boss – Attached to Shaft
May be Splined or tapered internally.
Stainless Steel 316 Grade

Transfers forward thrust via spigot to groove in the Boss above

Split for assembly and to allow the two halves to be tightened with 4 x SS 316 cap screws to prevent rotation over knurled boss surface due to spring tension

Ensure the alignment marks are now correctly located as per the diagram on page 9.

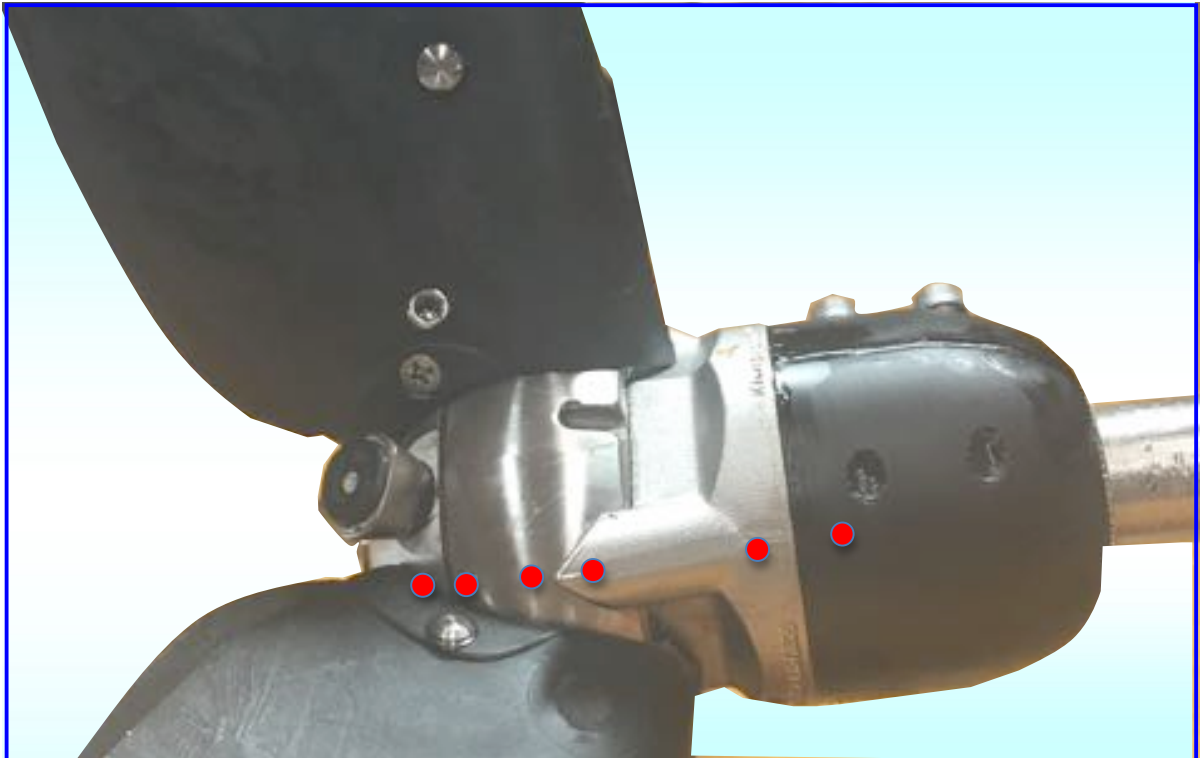
To assist with users in a situation where users have dis-assembled the unit for some reason and now need to ensure it is assembled correctly - a series of 5 pin punch marks is made down the length of the unit as shown in the picture below plus a small recess in the Acetal Nose Cone.

These extend from the Boss to the Blade Carrier down the leg of the tripod that is in line with these marks and then to the small hole drilled just as an indentation on the nose cone adjacent to the mark on the tripod.

The correct re-assembly of the unit will require that all these marks are re-aligned after final assembly including the correct pre tensioning of the torsional spring inside the unit.
