Kiwi Feather Props Ltd - LIMITED WARRANTY

VERSION DATED: 20.01.2019

K3 - CUSTOMER MANUAL

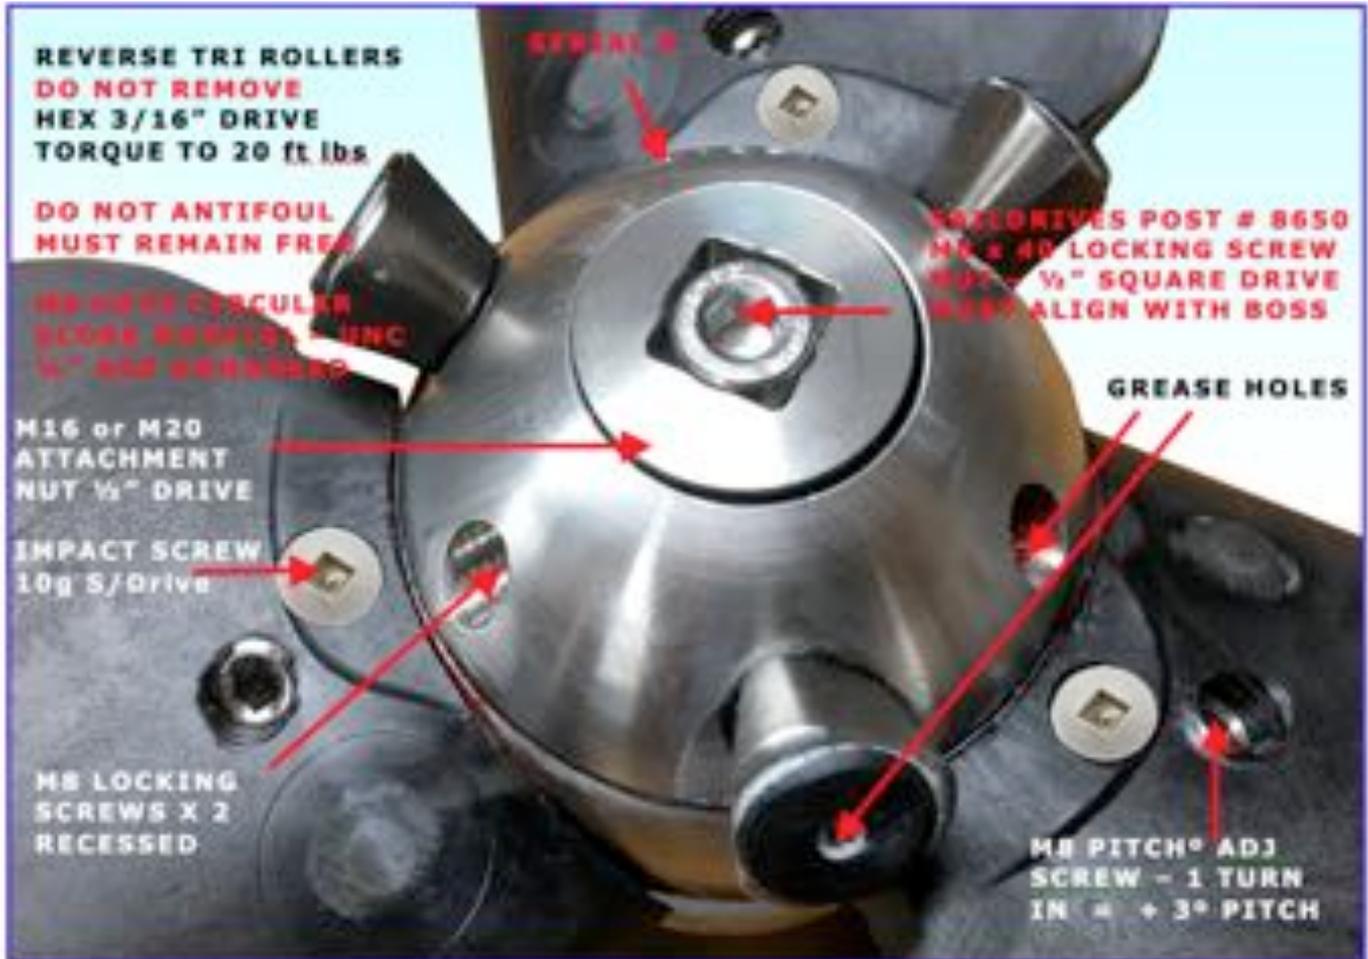
The photograph below shows a boss without the blades attached and clearly identifies the nut with its 1/2" square drive recess and the two M8 locking screws that must first be backed off to allow for removal of the nut from the unit.

NB: 1.250" NUTS PROTRUDE ~ 13 mm & ARE SHIPPED WRAPPED WITH KEY

APPLY Loctite™ or equivalent to the M16 or M20 NUT & M8 x 45 SCREW on all Saildrives. Any Medium or Strong grade is appropriate. It's presence is more important than grade.

NB: Always clean, dry and coat both male and female thread surfaces fully with Loctite[™] Any Medium or High Strength grade is appropriate. Remove the 2 x M8 locking screws. Insert into boss and only tighten down securely once the nut retaining the propeller is correctly locked in. Loctite[™] will set underwater in 24 hours.

DO NOT overtighten the nut which attaches to any standard ½ inch socket driver. This is particularly important on tapered shafts when you need to remove the propeller. Just nip it up using no more than an extra 20 foot lbs of torque or ~ 27 Nm. This is ~ equivalent to the weight of a two gallon or ten liter can of water suspended on your socket driver one foot or 300 mm from the nut.

SAILDRIVE nuts should be tightened to twice this torque – 40 ft-lbs or 54 Nm.

On Saildrives - finally fit the M8 Failsafe Screw inside the square drive nut and torque to ~ 5 ft-lbs or ~ 7Nm **NB: Cover both Nut & M8 male and female threads fully with Loctite™**

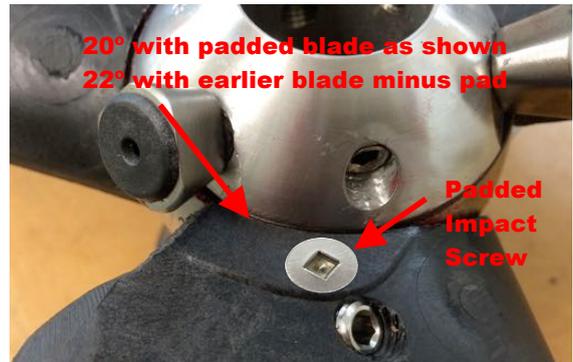
The photo shows a padded blade pushed into the forward thrust position to eliminate any slack with pitch set to 20 deg. The aft of the rear blade surface aligns with the SS aft joint line. Allow for any wear showing on the rear surface of the blade.

Add or subtract one degree of pitch using 1/3 rd of a turn = 1 degree of pitch. For example 22 degrees of pitch would be 2/3 rd of a turn in ie clockwise from the 20 Deg reference shown with padded blade. The screws are self locking into the blade.

One turn of the 8 mm pitch screw in a clockwise direction to each blade in turn will equate to 3 degrees of pitch [not inches of pitch] and substantially increase the power required from the engine and drive train. This will translate to lower engine revs. We would recommend adjustments be made in no more than exact half turn increments to each blade, which has the effect of varying engine revs by some 200 ~ 300 rpm. Each installation is unique and only experience can deliver the appropriate settings and optimal cruising revs for your vessel. A pitch setting of 21 degrees typically equates to a normal pitch of ~ 11 to 12 inches.

IMPORTANT: To avoid damaging the blade roots in reverse by exceeding the designed pitch settings when increasing the pitch, first lock the propeller by engaging ahead with the engine stopped. Rotate the propeller by hand into the reverse position against the spring, and then only increase the pitch until the blade comes up against the reversing rollers. *With Triangular rollers – turn the roller to contact the blade with a rounded section between the flats.*

NB: YOU WILL NOT BE ABLE TO EXCEED ~ 23.5° REPRESENTING THE MAX PITCH° AVAILABLE .

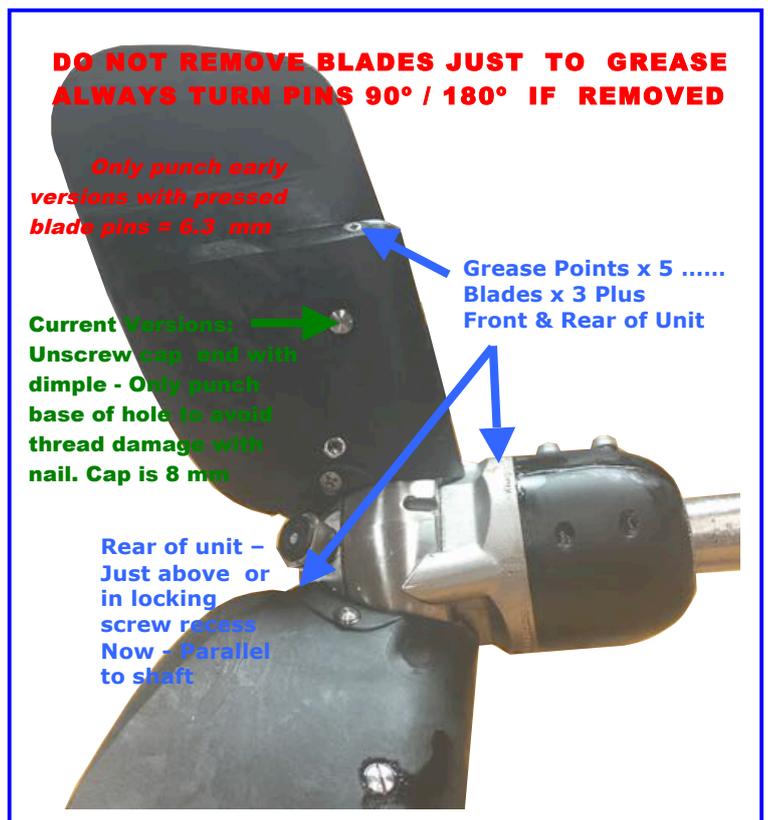
The *Kiwiprop™* contains lubricants sufficient until your next maintenance haul out. Each blade and reverse roller cap (if present) must then be greased via a lubrication point accessed by removing the small Pozidrive stainless screw on the blade face. In addition there are two small grease holes, one very close to the GF PP nose cone in the SS casting that takes the thrust of the pitch screws and one near the outer perimeter of the sphere at the rear of the unit inside the locking screw recess. These have been chamfered to accept a standard needle nosed grease point that we provide with every unit. **DO NOT OVER GREASE AND DAMAGE SEALS – JUST FILL – DO NOT FORCE EXCESS OUT.** Each of these grease points should be filled with a high quality marine grease: Grade - NLGI No 2: CALTEX Delo ESI has performed well and is readily available.

Check the reversing rollers are free to turn and free up if necessary with CRC. Grease the caps on later model units

Refer to **LUBRICATION** and **GREASING VIDEO** on our web site.

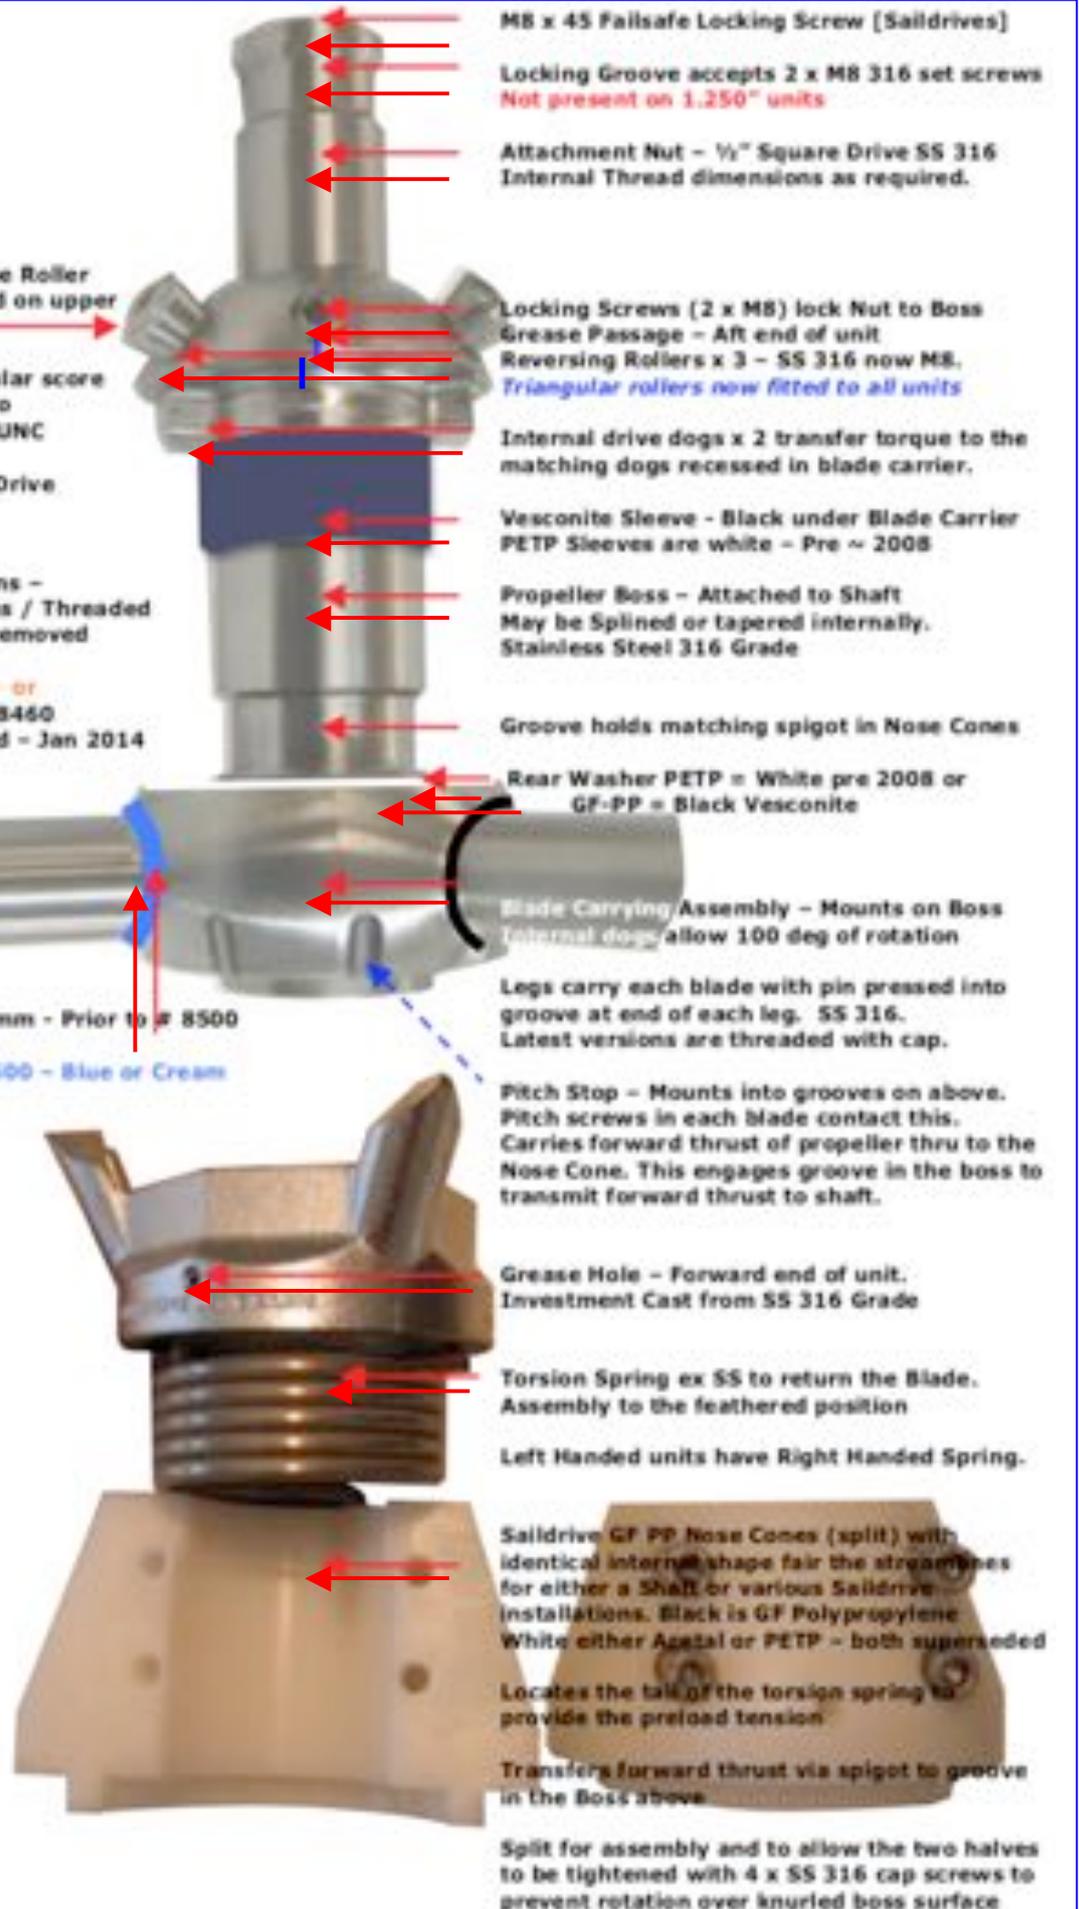
EXPLODED COMPONENTS DIAGRAM:

O-Rings 2.5 x 25 mm - Prior to # 8500

V Seals Post # 8500 - Blue or Cream

MB x 45 Failsafe Locking Screw [Saildrives]

Locking Groove accepts 2 x MB 316 set screws
Not present on 1.250" units

Propeller Boss - Attached to Shaft
May be Splined or tapered internally.
Stainless Steel 316 Grade

Refer first to exploded diagram on page 9 below and to the picture of the boss on page 2

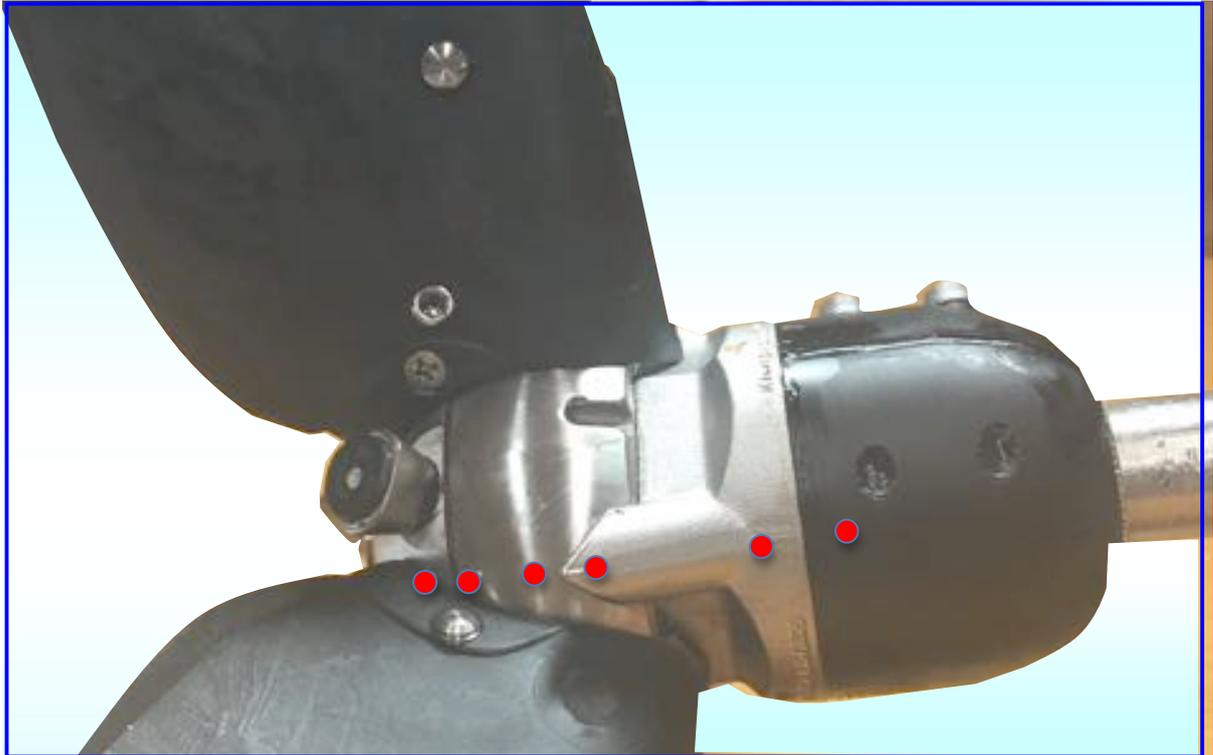
These extend from the Boss to the Blade Carrier down the leg of the tripod that is in line with these marks and then to the small hole drilled just as an indentation on the nose cone adjacent to the mark on the tripod.

The correct re-assembly of the unit will require that all these marks are re-aligned after final assembly including the correct pre tensioning of the torsional spring inside the unit.

Ensure the alignment marks are now correctly located as per the diagram on page 9.

WARNING: Customers are strongly advised not to attempt to disassemble the unit unless this becomes absolutely essential. Re-assembly of all the components coupled with the need to ensure sealant is inserted into the nose cone whilst at the same time preloading the internal torsion spring makes for a tricky operation, particularly if no stub shaft is available to hold the unit whilst these operations are completed.
