Kiwi Feather Props Ltd - LIMITED WARRANTY

VERSION DATED: 20.05.2023

CONTENTS OF THIS MANUAL

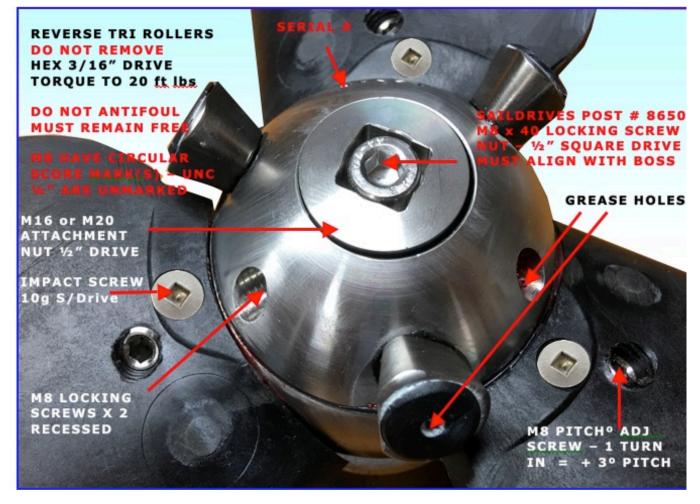
The photograph below shows a boss without the blades attached and clearly identifies the nut with it's $\frac{1}{2}$ " square drive recess and the **two M8 locking screws** that must first be backed off to allow for removal of the nut from the unit.

NB: 1.250" NUTS PROTRUDE ~ 13 mm & ARE SHIPPED WRAPPED WITH KEY

APPLY Loctite[™] or equivalent to the M16 or M20 NUT & M8 x 45 Cap screw on all Saildrives. Any Medium or Strong grade is appropriate. Its presence is more important than grade.

On Saildrives - finally fit the M8 Failsafe Cap Screw inside the square drive nut and torque to

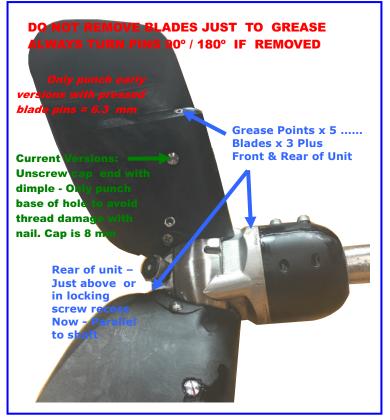
Kiwiprop™ contains **lubricants** sufficient until your next maintenance haul out. Each blade and reverse roller cap (if present) must then be greased via a lubrication point accessed by removing the small Pozidrive stainless screw on the blade face. In addition there are two small grease holes, one very close to the GF PP nose cone in the SS casting that takes the thrust of the pitch screws and one near the outer perimeter of the sphere at the rear of the unit inside the locking screw recess. These have been chamfered to accept a standard needle nosed grease point that we provide with every unit. DO NOT OVER GREASE AND DAMAGE SEALS JUST FILL - DO NOT FORCE EXCESS OUT. Each of these grease points should be filled with a high quality marine grease: Grade - NLGI No 2: CALTEX Delo ESI has

Refer to LUBRICATION and GREASING WEB PAGE ON BLADE MOUNTING COVERS LATER PIN VERSIONS WITH THREADED CAPS IN DETAIL

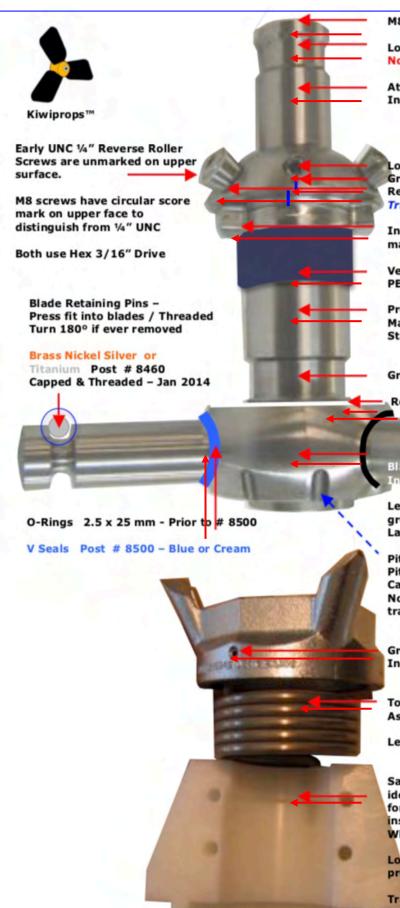
M8 x 45 Failsafe Locking Screw [Saildrives]

Locking Groove accepts 2 x M8 316 set screws Not present on 1.250" units

Propeller Boss – Attached to Shaft May be Splined or tapered internally. Stainless Steel 316 Grade

Refer first to exploded diagram on page 9 below and to the picture of the boss on page 2

Ensure the alignment marks are now correctly located as per the diagram on page 9.

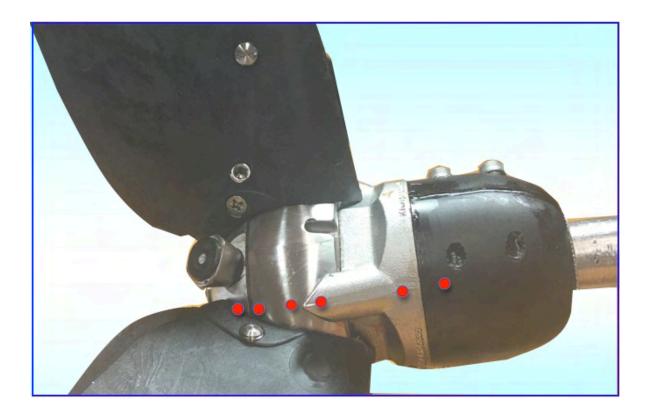
These extend from the Boss to the Blade Carrier down the leg of the tripod that is in line with these marks and then to the small hole drilled just as an indentation on the nose cone adjacent to the mark on the tripod.

The correct re-assembly of the unit will require that all these marks are re-aligned after final assembly including the correct pre tensioning of the torsional spring inside the unit.
