Kiwi Feather Props Ltd – LIMITED WARRANTY

K4 - CUSTOMER MANUAL

VERSION: 20.10.2020

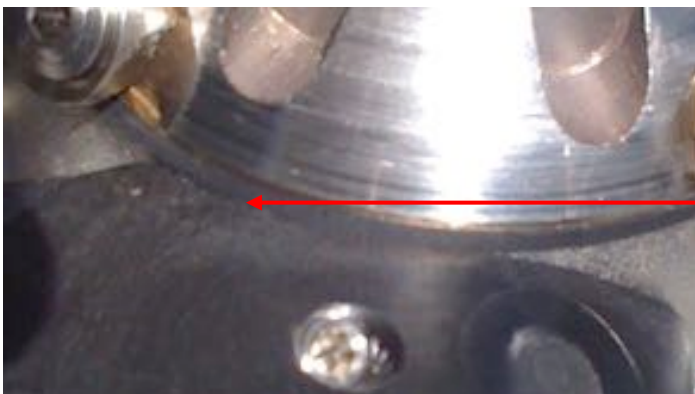
This photo shows the rear of the blade aligned with the front of the aft seal which will equate to ~ 20 ° of pitch.

Increasing the pitch by screwing the pitch screw IN to align the blade surface with the rear edge of the seal will equate to ~ 23 °

One turn of the 8 mm pitch screw in a clockwise direction to each blade in turn will equate to 3 degrees of pitch [not inches of pitch] and substantially increase the power required from the engine and drive train. This will translate to lower engine revs. We would recommend adjustments be made in no more than exact half turn increments to each blade, which has the effect of varying engine revs by some 200 ~ 300 rpm. Each installation is unique and only experience can deliver the appropriate settings and optimal cruising revs for your vessel. A pitch setting of 21 degrees on a 17" unit typically equates to a normal pitch of ~ 11 to 12 inches. [The required Allen key is 5/32" or 4 mm]
