Kiwi Feather Props Ltd - LIMITED WARRANTY

VERSION DATED: 01.09.2016

K4 - CUSTOMER MANUAL

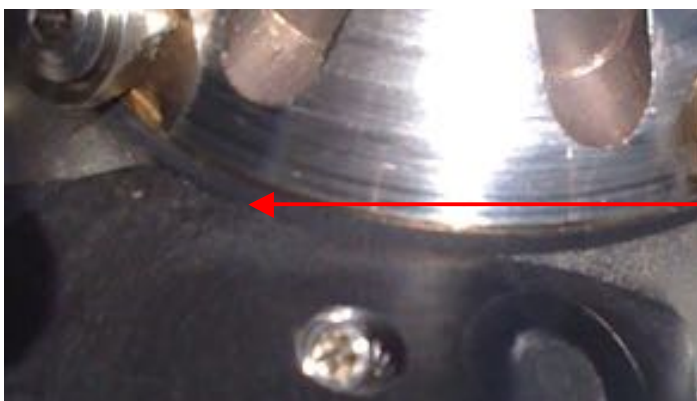
This photo shows the rear of the blade aligned with the front of the aft seal which will equate to ~ 20 ° of pitch.

Increasing the pitch by screwing the pitch screw IN to align the blade surface with the rear edge of the seal will equate to ~ 23 °

One turn of the 8 mm pitch screw in a clockwise direction to each blade in turn will equate to 3 degrees of pitch [not inches of pitch] and substantially increase the power required from the engine and drive train. This will translate to lower engine revs. We would recommend adjustments be made in no more than exact half turn increments to each blade, which has the effect of varying engine revs by some 200 ~ 300 rpm. Each installation is unique and only experience can deliver the appropriate settings and optimal cruising revs for your vessel. A pitch setting of 21 degrees on a 17" unit typically equates to a normal pitch of ~ 11 to 12 inches. [The required Allen key is 5/32" or 4 mm]

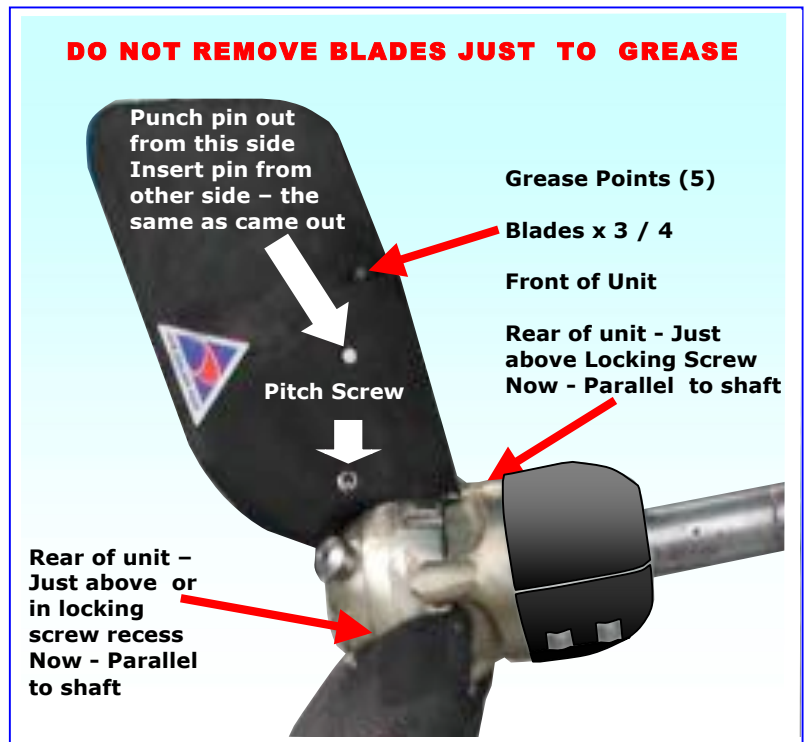
WEB PAGE ON BLADE MOUNTING COVERS LATER PIN VERSIONS WITH THREADED CAPS IN DETAIL

Check the blade has been remounted on it's old pin. Now mount the retaining pin back into the reverse face of the blade from the side it came out of with a new wear face on the pin facing outwards. By tapping gently - reinsert the pin so that it is equidistant from each outer face of the blade. Refer photograph above for illustration.
